# DETAILED ENGINEERING EVALUATION PROCEDURE – DEVELOPMENT DRAFT

## DISCUSSION DOCUMENT FOR CONSIDERATION BY CSG

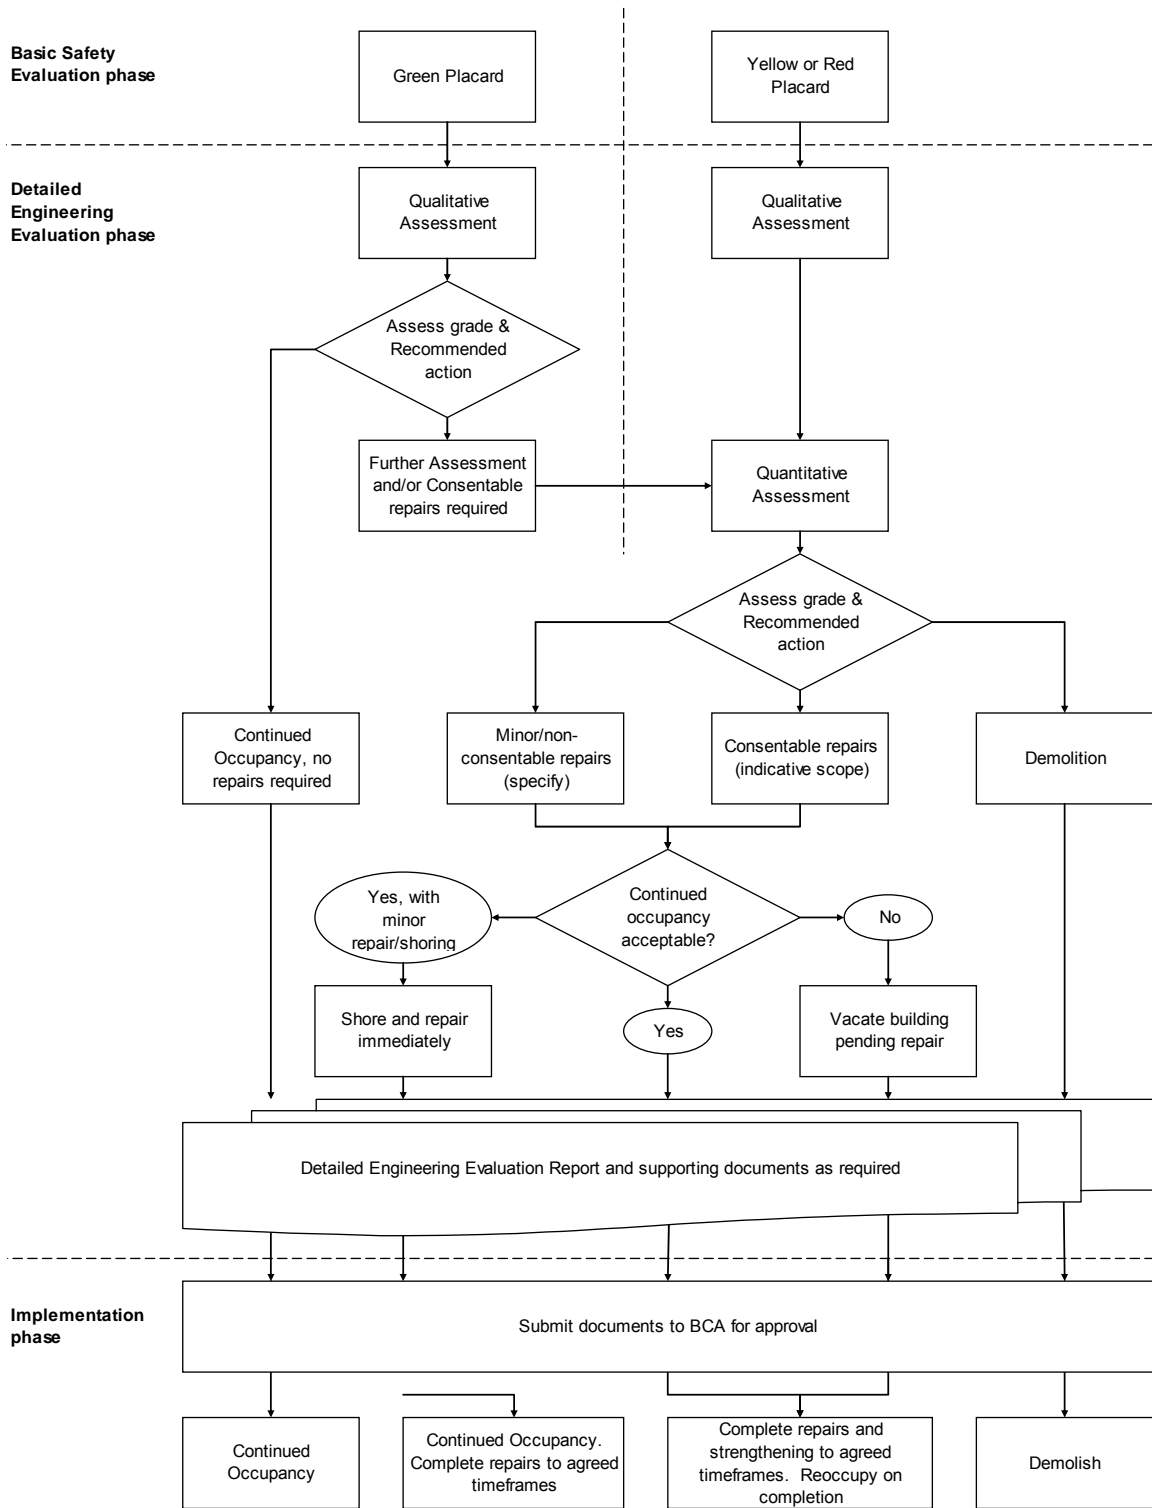
Figure 1: Detailed Engineering Evaluation - Overall Procedure Outline

It is proposed to complete the evaluation in two parts, the first qualitative and the second, quantitative. The extent of the qualitative assessment will be determined initially from the placard and then from detailed damage observations, recognising that the Basic Safety Evaluation (BSE) Procedure is superficial in nature, intended only to give a broad picture of overall damage levels for planning. The detailed evaluation process is outlined in Figure 1 below. Both the qualitative and the quantitative procedures are described separately below.
